## A Demolition Survey Report for Asbestos-Containing Materials at:

**SITE LOCATION:** Changing Rooms and Toilet Block in Church Road, Wootton, Bedfordshire, MK43 9EU

**PREPARED FOR:** Wootton Parish Council

**SURVEY REF:** AGG 611

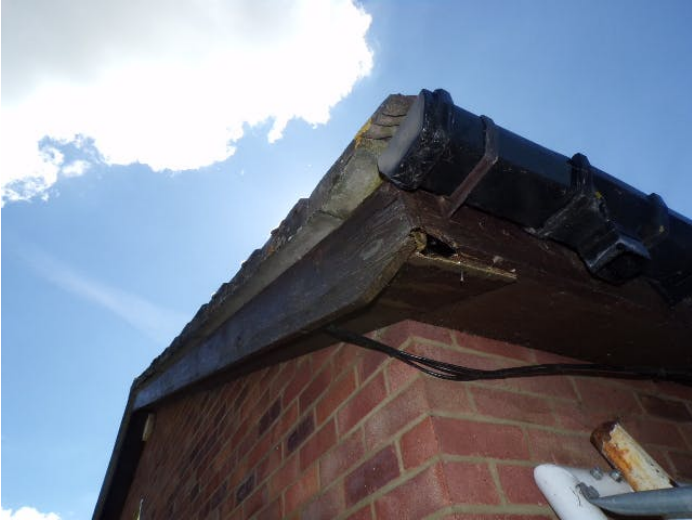
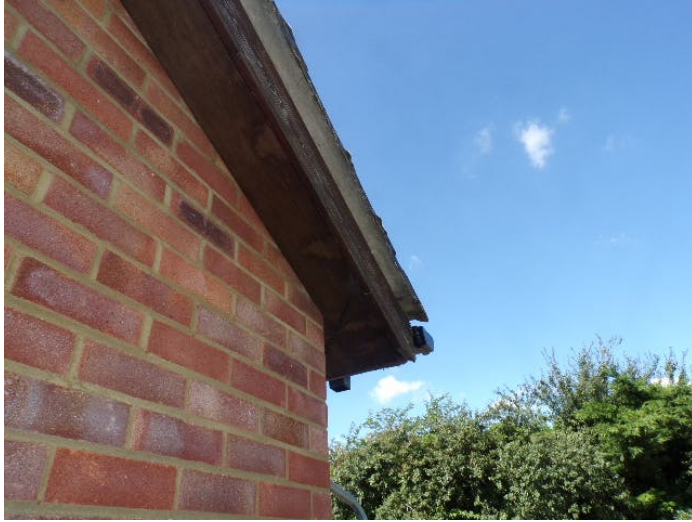
| Location | around the building | Item | undercloak boards |
| Material | asbestos cement | Extent | 2 x 8 L M |
| Strategy / Sample Id | Sample / S4 | Fibre Type | NADIS |

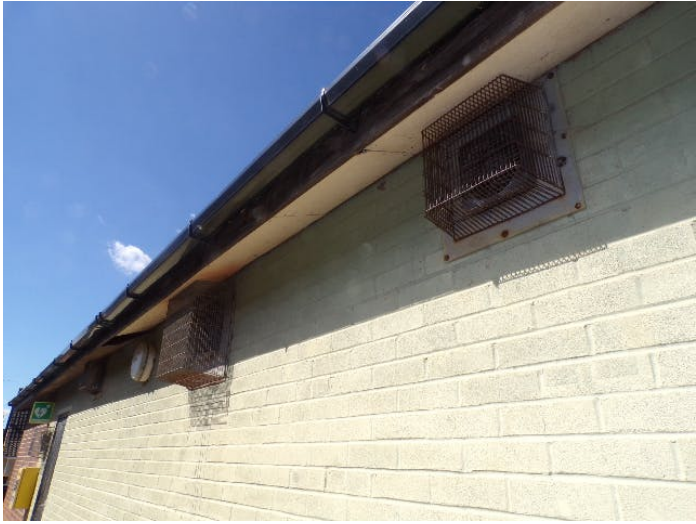
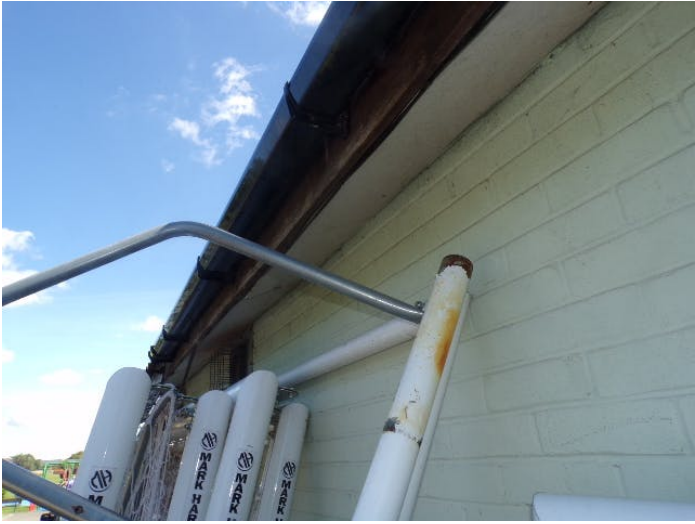
Changing Rooms > external > around the building > soffit boards (grey boards)

| Location | around the building | Item | soffit boards (grey boards) |
| Material | asbestos cement | Extent | 17 L M |
| Strategy / Sample Id | Sample / S5 | Fibre Type | NADIS |

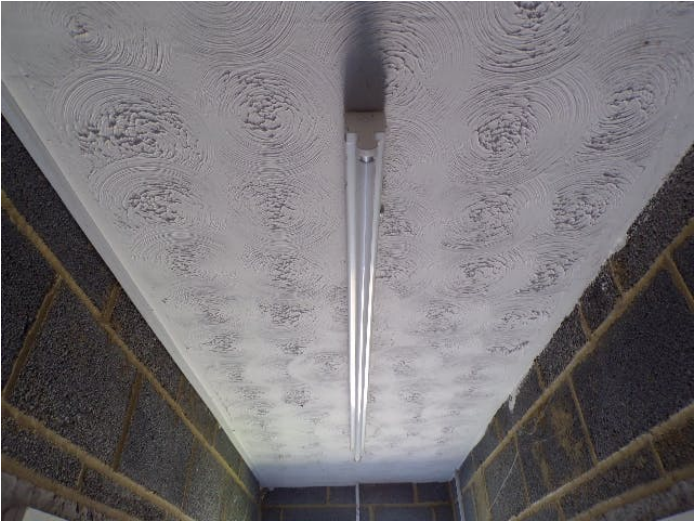
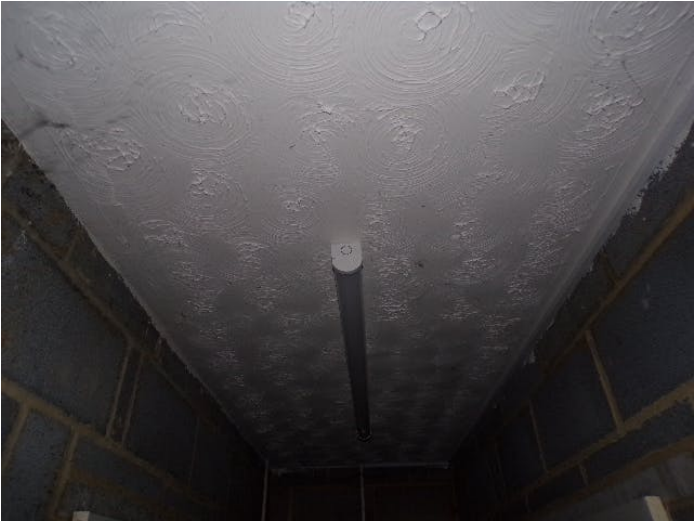
Changing Rooms > ground floor > 001 - main entrance and corridor > on the ceiling (either ends, extensions)

| Location | 001 - main entrance and corridor | Item | on the ceiling (either ends, extensions) |
| Material | textured coating | Extent | 6 SQ. M. |
| Strategy / Sample Id | Sample / S1 | Fibre Type | NADIS |

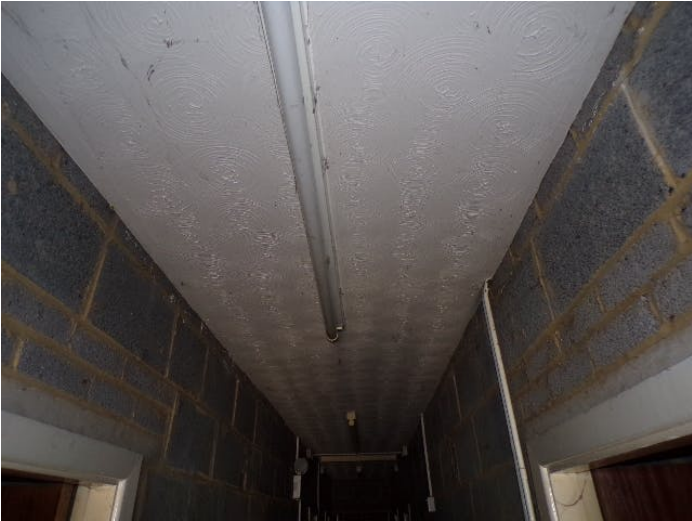
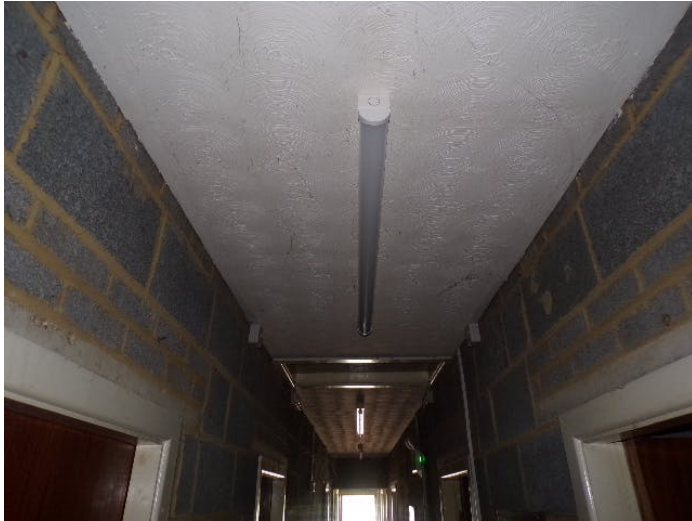
## Changing Rooms > ground floor > 001 - main entrance and corridor > on the ceiling (middle section, the original building)

| Location | 001 - main entrance and corridor | Item | on the ceiling (middle section, the original building) |
| Material | textured coating | Extent | 9.5 SQ. M. |
| Strategy / Sample Id | Sample / S2 | Fibre Type | Chrysotile |

| Product Type (or Debris from Product) | 1 | Extent of Damage / Deterioration | 0 |

| Recommendation | Non-licensable material.<br>Remove and dispose of as asbestos waste | | |

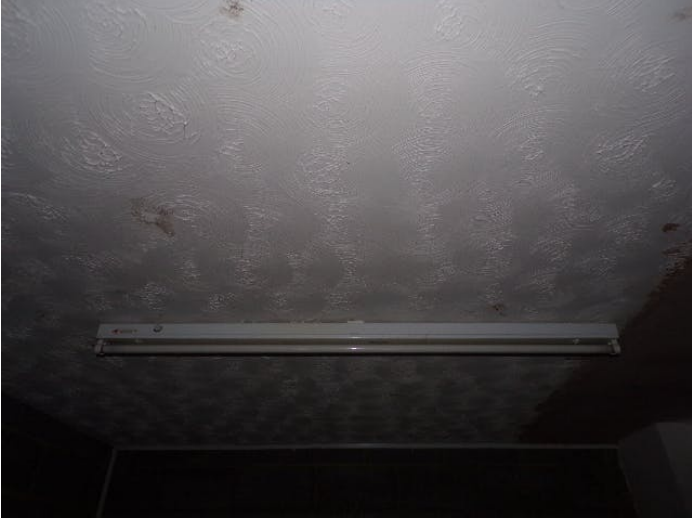
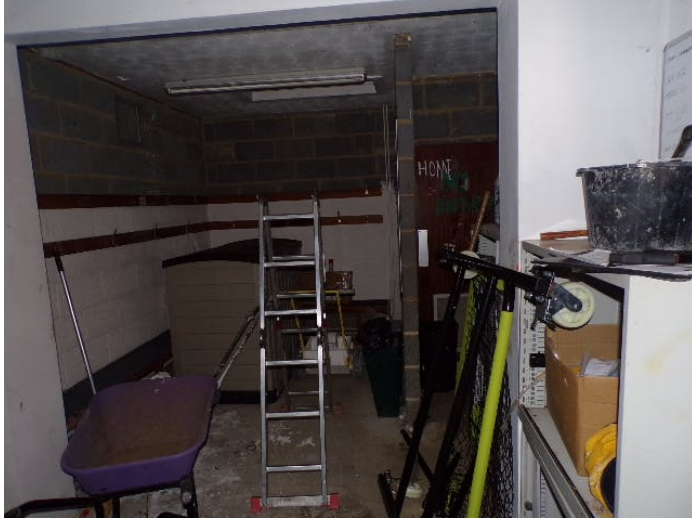
| Location | 002 - double changing room | Item | on the ceiling (extension) |
| Material | textured coating | Extent | 9.5 SQ. M. |
| Strategy / Sample Id | Strongly Presume / S1 | Presumed Fibre Type | NADIS |

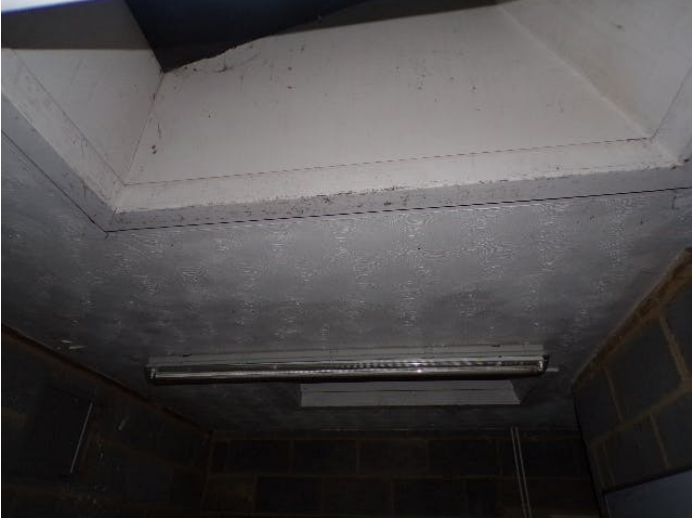
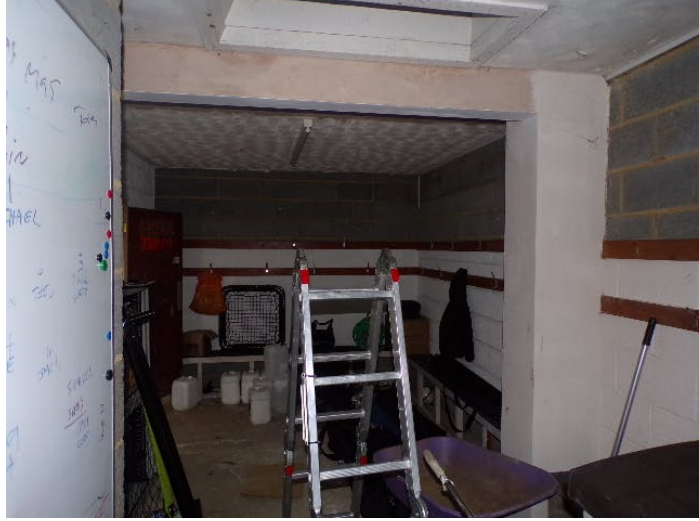
## Changing Rooms > ground floor > 002 - double changing room > on the ceiling (original part)

| Location | 002 - double changing room | Item | on the ceiling (original part) |
| Material | textured coating | Extent | 10 SQ. M. |
| Strategy / Sample Id | Strongly Presume / S2 | Presumed Fibre Type | Chrysotile |

| Product Type (or Debris from Product) | 1 | Extent of Damage / Deterioration | 1 |

| Recommendation | Non-licensable material.<br>Remove and dispose of as asbestos waste | | |

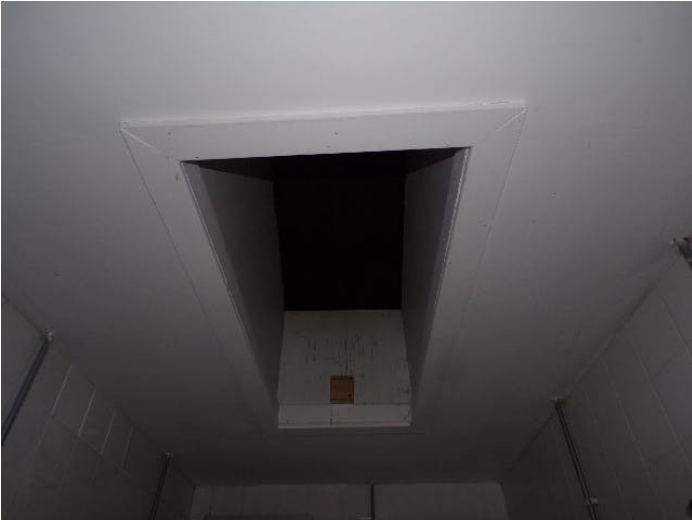
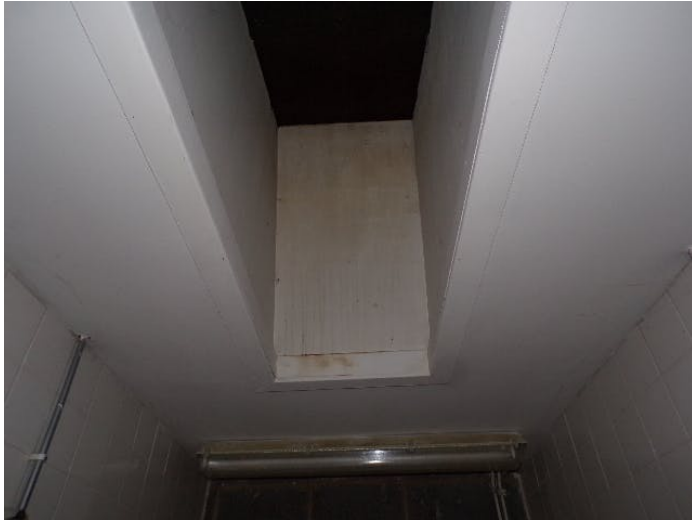
| Location | 003 - shower room | Item | on the ceiling |
| Material | textured coating below skimmed plaster | Extent | 3.6 SQ. M. |
| Strategy / Sample Id | Strongly Presume / S2 | Presumed Fibre Type | Chrysotile |

| Product Type (or Debris from Product) | 1 | Extent of Damage / Deterioration | 0 |

| Recommendation | Non-licensable material.<br>Remove and dispose of as asbestos waste | | |

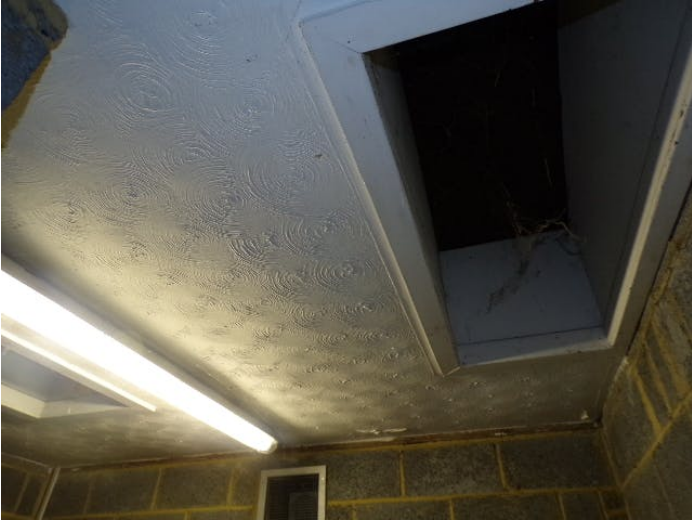
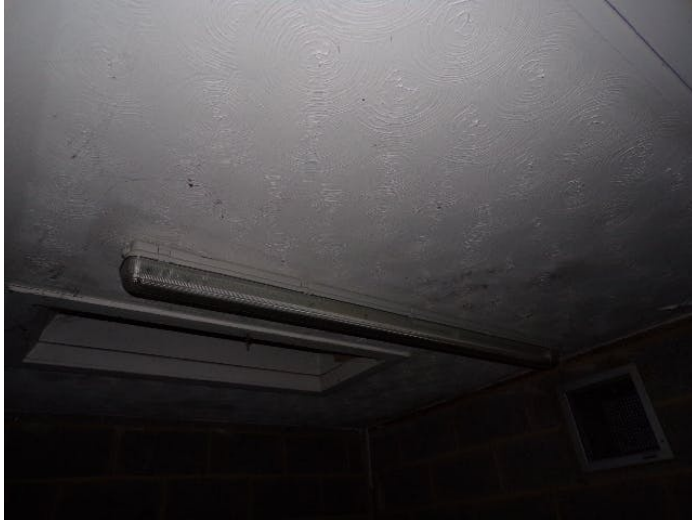
| Location | 004 - changing room | Item | on the ceiling |
| Material | textured coating | Extent | 9.5 SQ. M. |
| Strategy / Sample Id | Strongly Presume / S2 | Presumed Fibre Type | Chrysotile |

| Product Type (or Debris from Product) | 1 | Extent of Damage / Deterioration | 1 |

| Recommendation | Non-licensable material.<br>Remove and dispose of as asbestos waste | | |

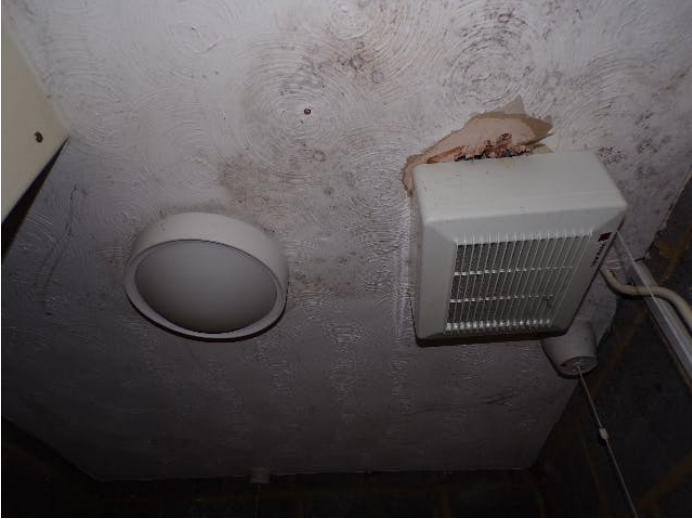
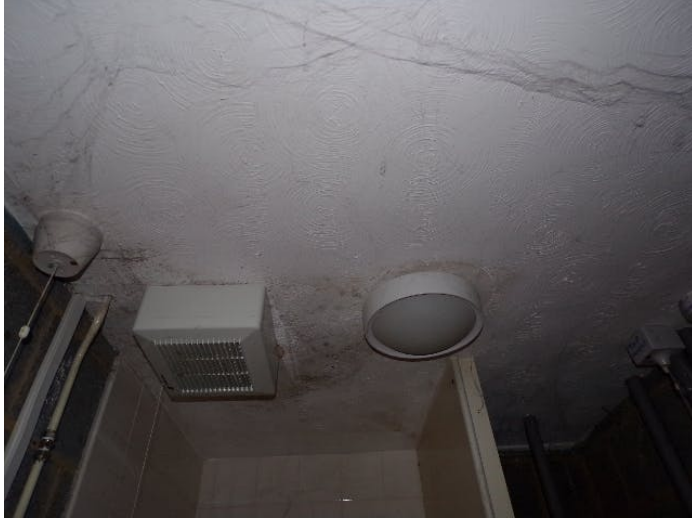
## Changing Rooms > ground floor > 005 - single shower room > on the ceiling

| Location | 005 - single shower room | Item | on the ceiling |
| Material | textured coating | Extent | 3 SQ. M. |
| Strategy / Sample Id | Strongly Presume / S2 | Presumed Fibre Type | Chrysotile |

| Product Type (or Debris from Product) | 1 | Extent of Damage / Deterioration | 1 |

| Recommendation | Non-licensable material.<br>Remove and dispose of as asbestos waste | | |

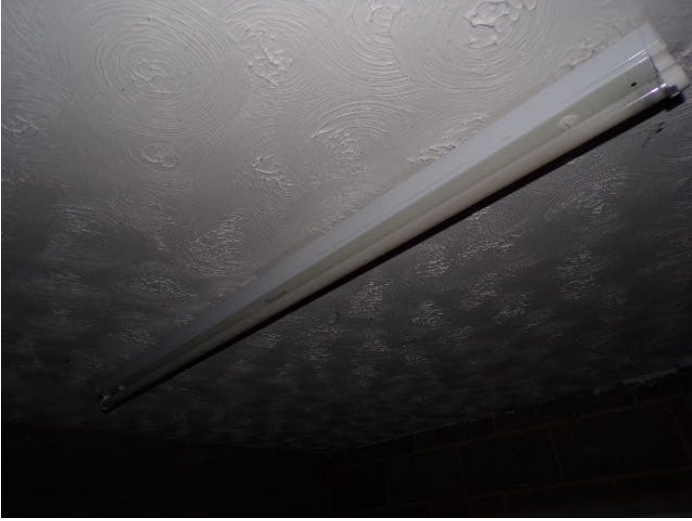
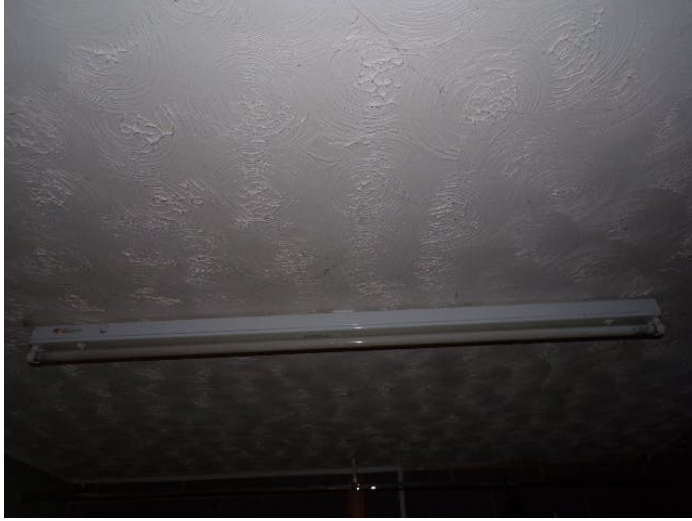
| Location | 006 - changing room | Item | on the ceiling (either ends) |
| Material | textured coating | Extent | 9.2 SQ. M. |
| Strategy / Sample Id | Strongly Presume / S1 | Presumed Fibre Type | NADIS |

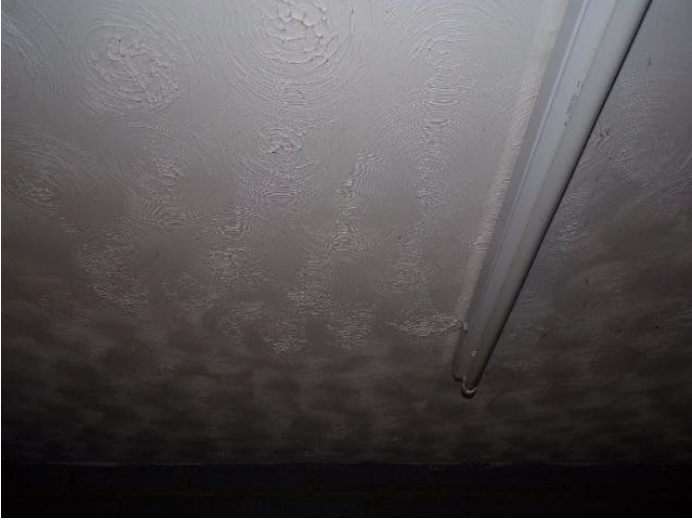
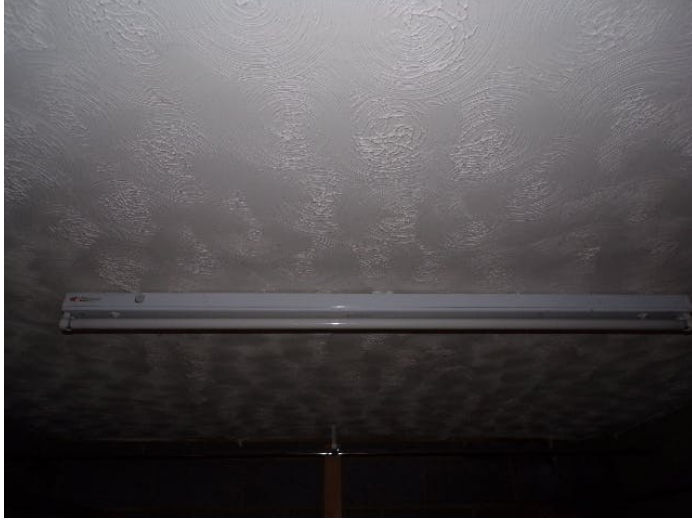
## Changing Rooms > ground floor > 007 - changing room > on the ceiling (either ends)

| Location | 007 - changing room | Item | on the ceiling (either ends) |
| Material | textured coating | Extent | 9.2 SQ. M. |
| Strategy / Sample Id | Strongly Presume / S1 | Presumed Fibre Type | NADIS |

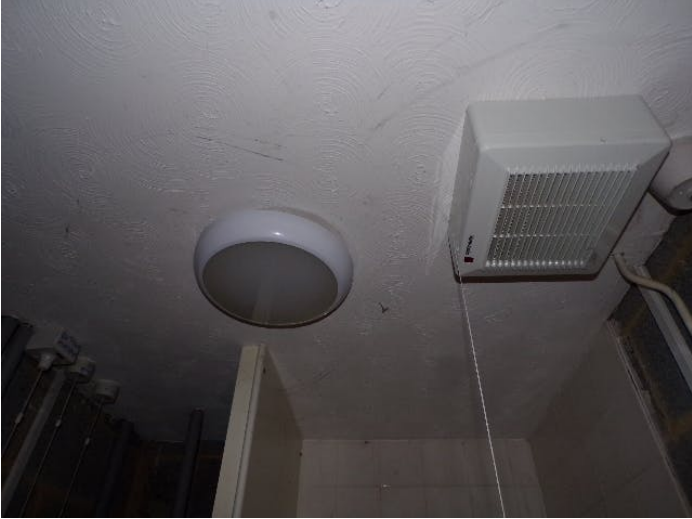
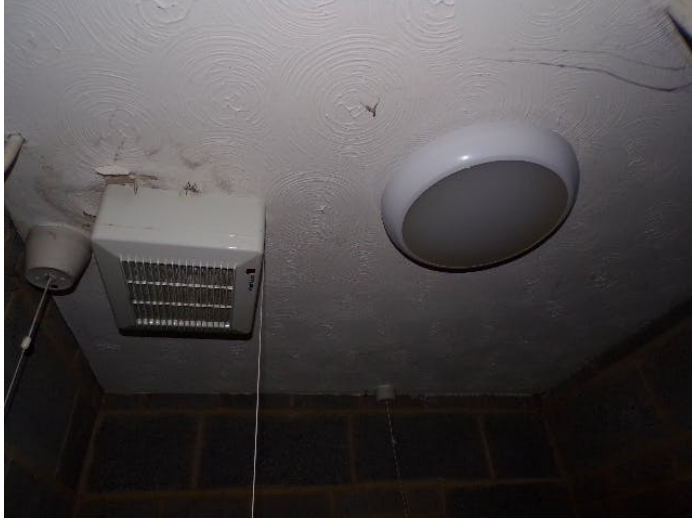
## Changing Rooms > ground floor > 008 - single shower room > on the ceiling

| Location | 008 - single shower room | Item | on the ceiling |
| Material | textured coating | Extent | 2.9 SQ. M. |
| Strategy / Sample Id | Strongly Presume / S2 | Presumed Fibre Type | Chrysotile |

| Product Type (or Debris from Product) | 1 | Extent of Damage / Deterioration | 0 |

| Recommendation | Non-licensable material.<br>Remove and dispose of as asbestos waste | | |

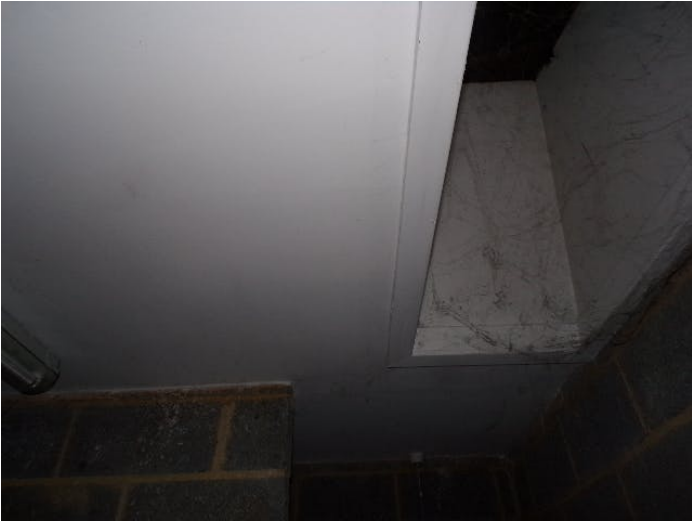
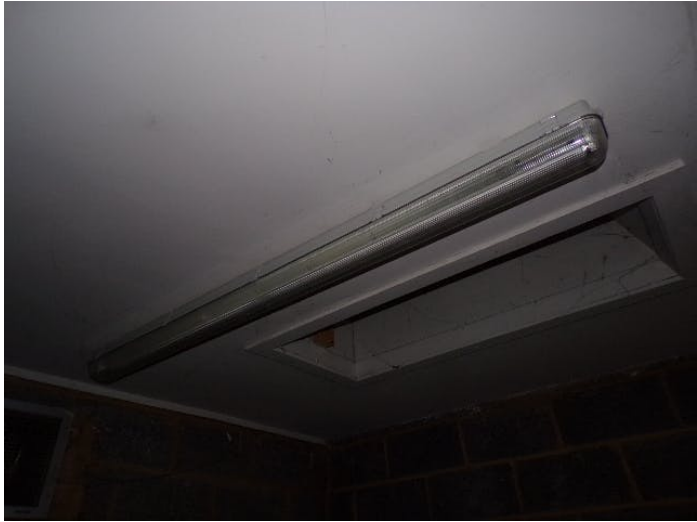
| Location | 009 -changing room | Item | on the ceiling |
| Material | textured coating below skimmed plaster | Extent | 9.2 SQ. M. |
| Strategy / Sample Id | Strongly Presume / S2 | Presumed Fibre Type | Chrysotile |

| Product Type (or Debris from Product) | 1 | Extent of Damage / Deterioration | 0 |

| Recommendation | Non-licensable material.<br>Remove and dispose of as asbestos waste | | |

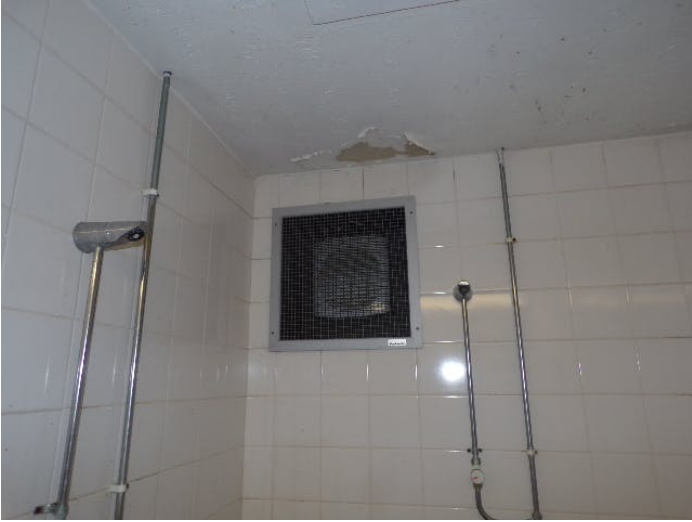
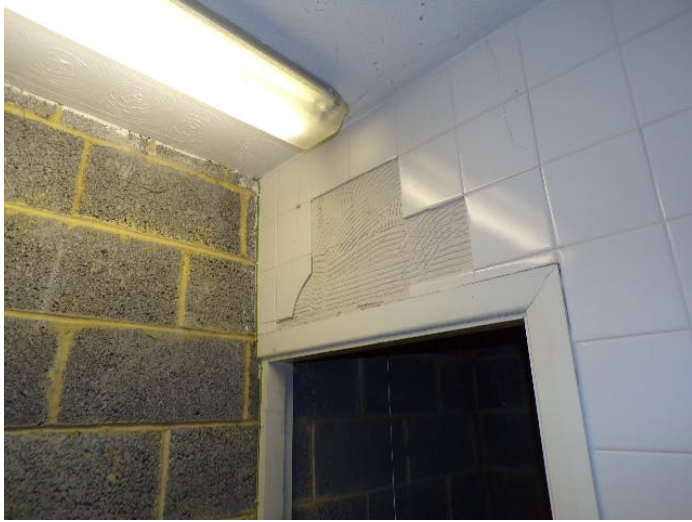
| Location | 010 - shower room | Item | on the ceiling |
| Material | textured coating | Extent | 4.6 SQ. M. |
| Strategy / Sample Id | Strongly Presume / S2 | Presumed Fibre Type | Chrysotile |

| Product Type (or Debris from Product) | 1 | Extent of Damage / Deterioration | 0 |

| Recommendation | Non-licensable material.<br>Remove and dispose of as asbestos waste | | |

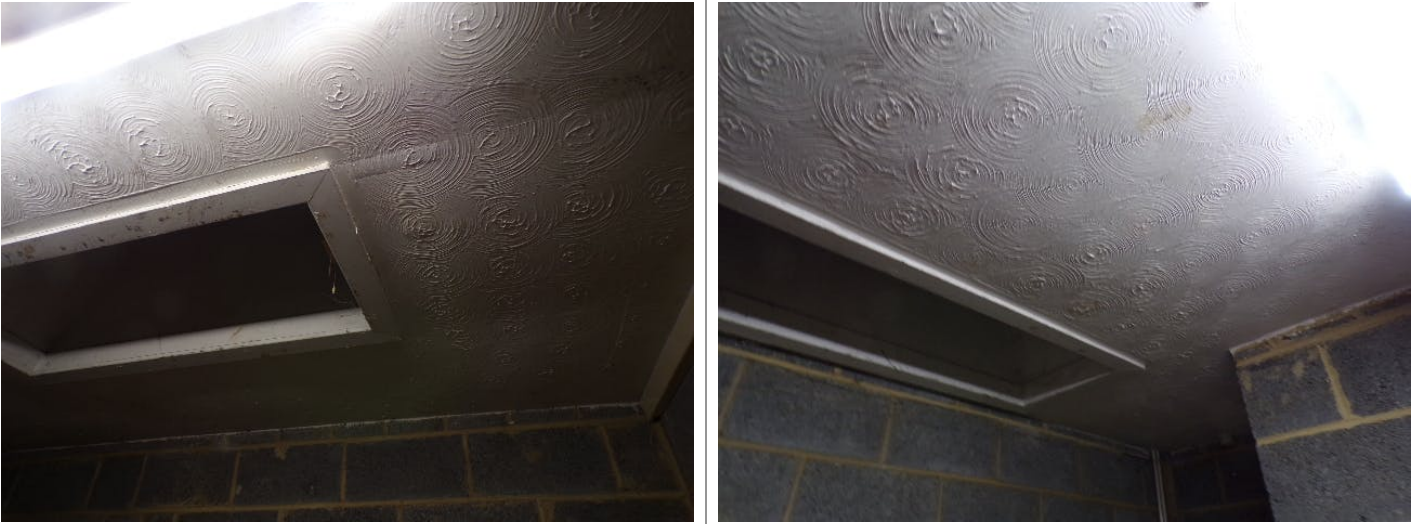
| Location | 011 - changing room | Item | on the ceiling |
| Material | textured coating | Extent | 9.3 SQ. M. |
| Strategy / Sample Id | Strongly Presume / S2 | Presumed Fibre Type | Chrysotile |

| Product Type (or Debris from Product) | 1 | Extent of Damage / Deterioration | 0 |

| Recommendation | Non-licensable material.<br>Remove and dispose of as asbestos waste | | |

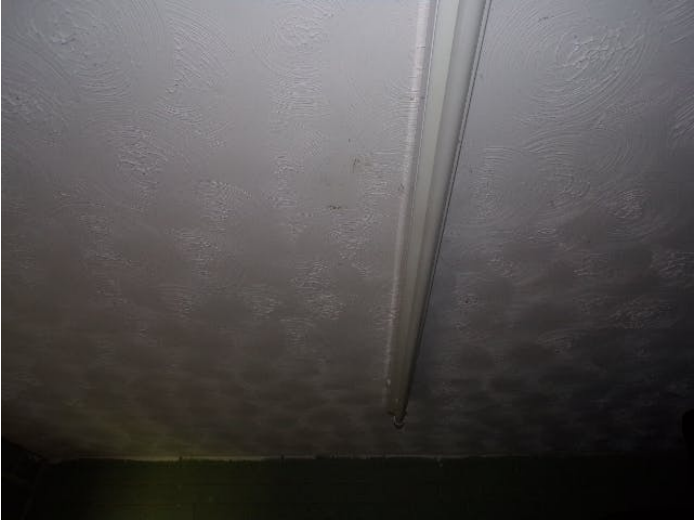
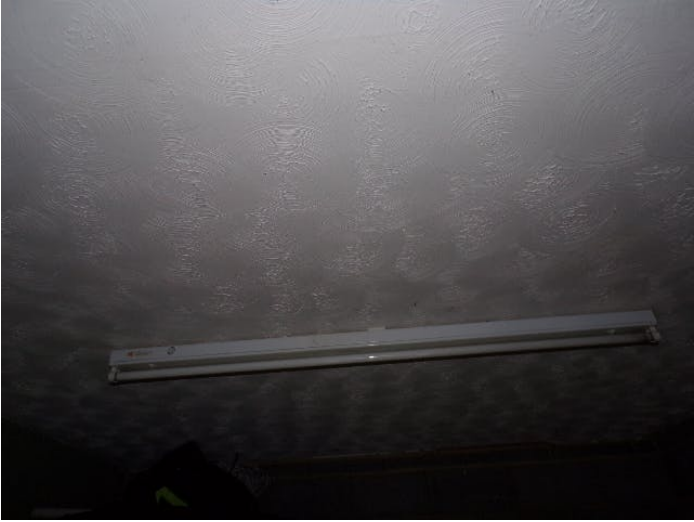
| Location | 012 - changing room | Item | on the ceiling |
| Material | textured coating | Extent | 9.2 SQ. M. |
| Strategy / Sample Id | Strongly Presume / S1 | Presumed Fibre Type | NADIS |

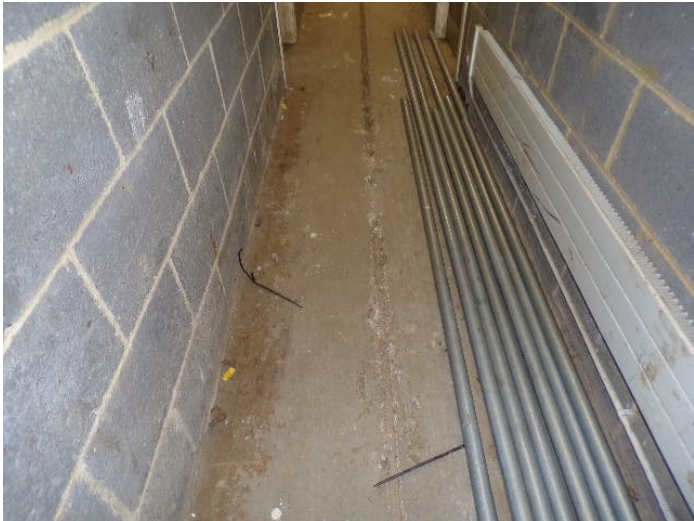
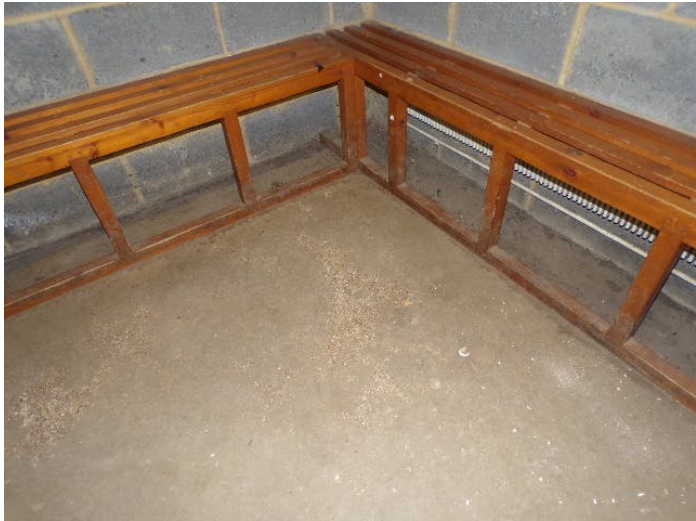
Changing Rooms > ground floor > throughout all rooms >

| Access / Notes | No Access / Not accessed within or below concrete floor slab | | |

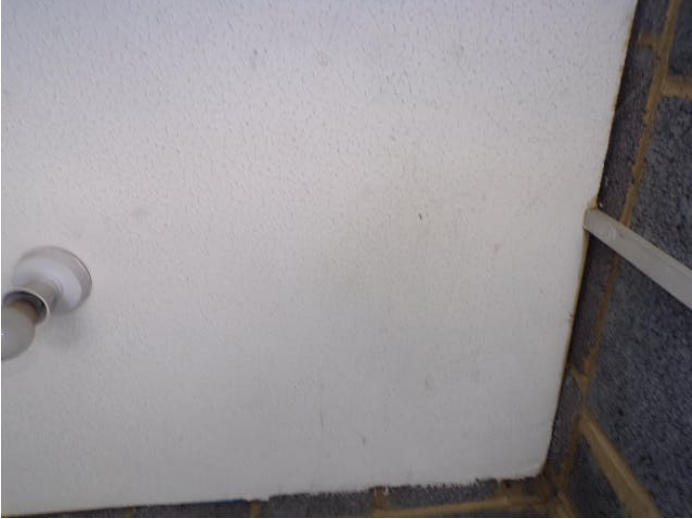
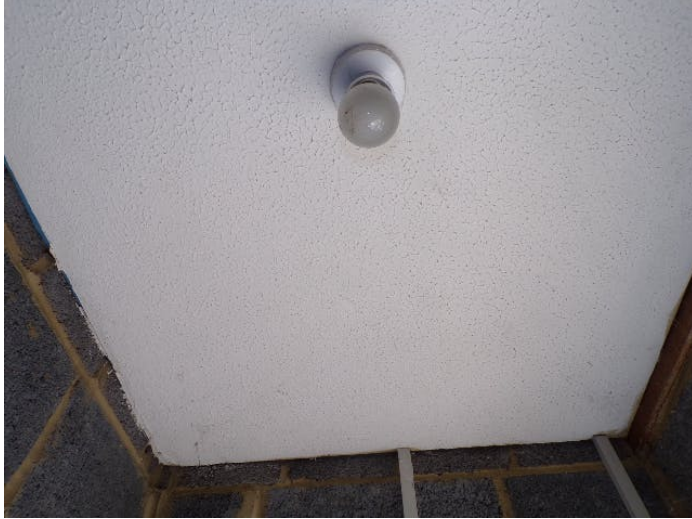
## Changing Rooms > ground floor, external > 014 - boiler room > on the ceiling

| Location | 014 - boiler room | Item | on the ceiling |
| Material | textured coating | Extent | 1.5 SQ. M. |
| Strategy / Sample Id | Strongly Presume / S3 | Presumed Fibre Type | Chrysotile |

| Product Type (or Debris from Product) | 1 | Extent of Damage / Deterioration | 0 |

| Recommendation | Non-licensable material.<br>Remove and dispose of as asbestos waste | | |

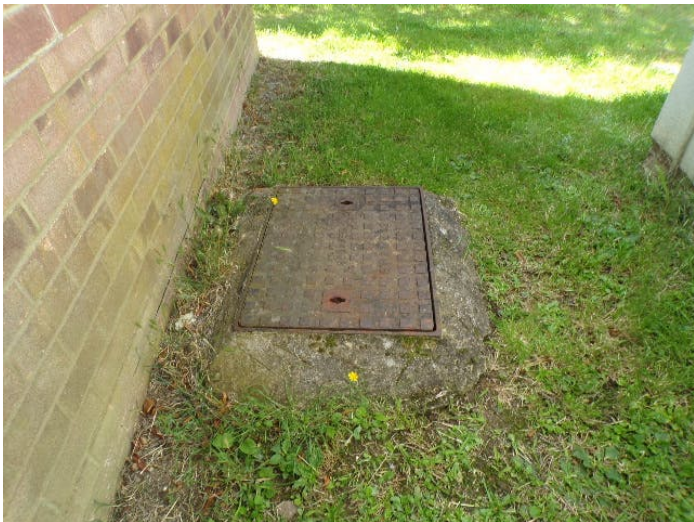
Changing Rooms > ground floor, external > between changing rooms and toilet block > below drain cover

| Access / Notes | No Access / outside the scope of this survey | | |

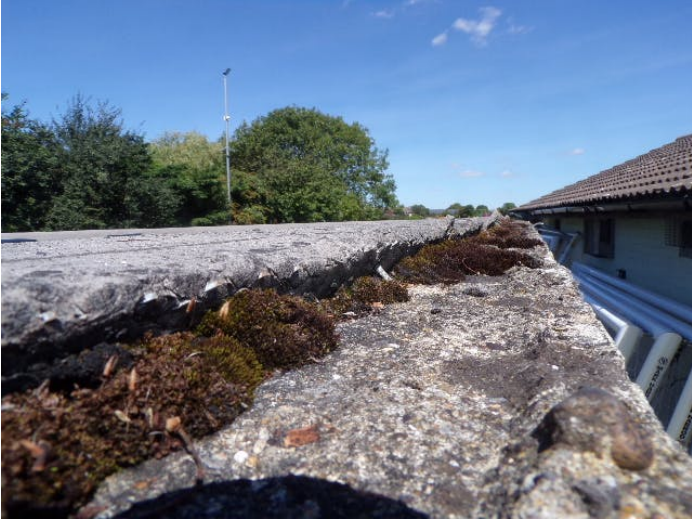
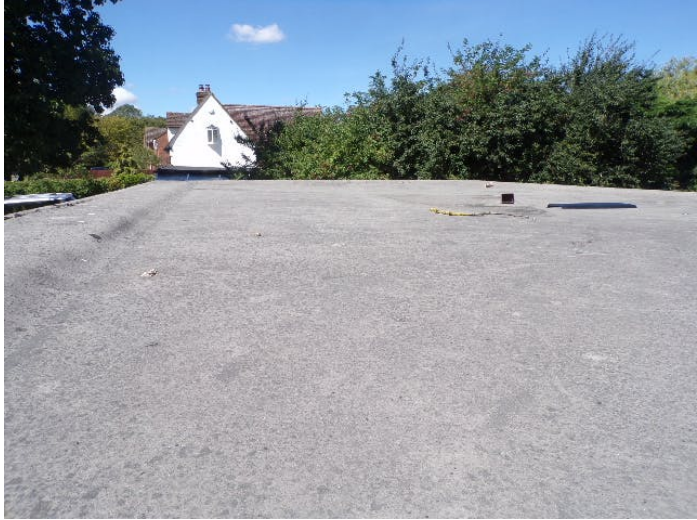
## Toilet Block > external > around the building > roof covering

| Location | around the building | Item | roof covering |
| Material | bituminous on expanding metal/concrete slab | Extent | 16 SQ. M. |
| Strategy / Sample Id | Sample / S6 | Fibre Type | NADIS |

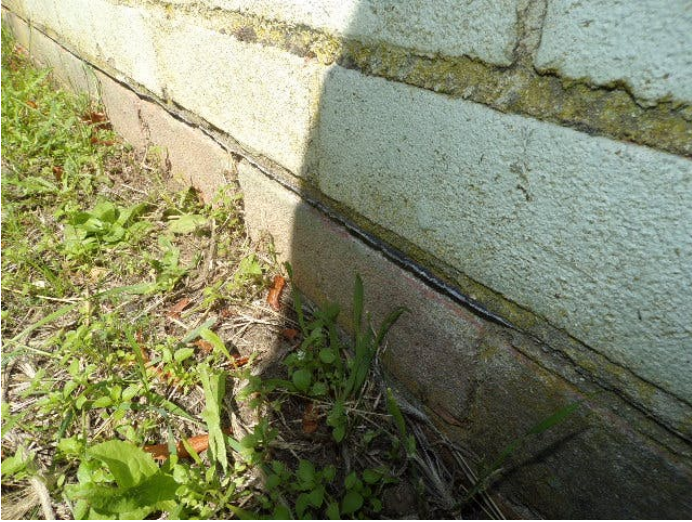
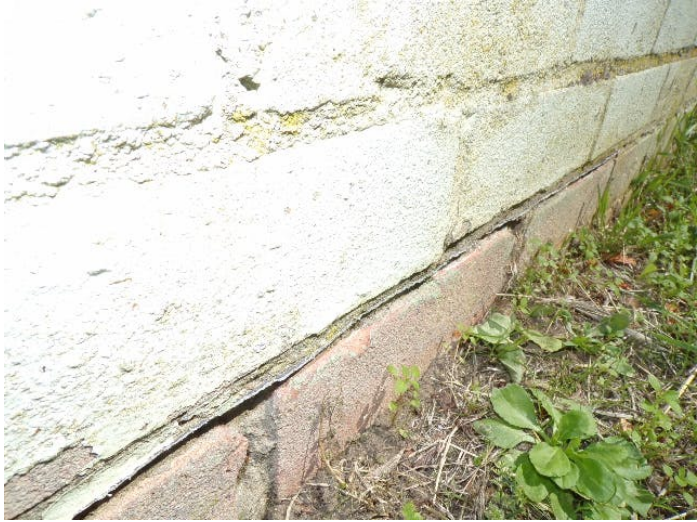
## Toilet Block > external > around the building > damp proof course

| Location | around the building | Item | damp proof course |
| Material | bituminous felt | Extent | 17 L M |
| Strategy / Sample Id | Sample / S7 | Fibre Type | Chrysotile |

| Product Type (or Debris from Product) | 1 | Extent of Damage / Deterioration | 0 |

| Recommendation | Non-licensable material.<br>Remove and dispose of as asbestos waste | | |

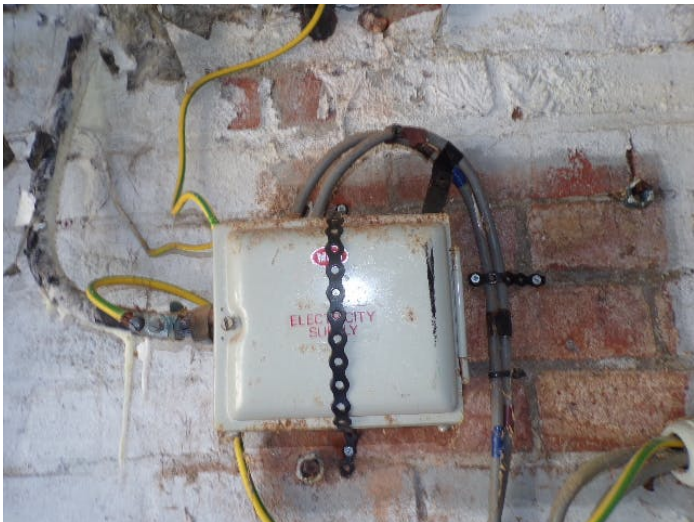
| Location | 003 - Gents toilet | Item | within main electric switch box |
| Access / Notes | No Access / Live at the time of this survey | | |

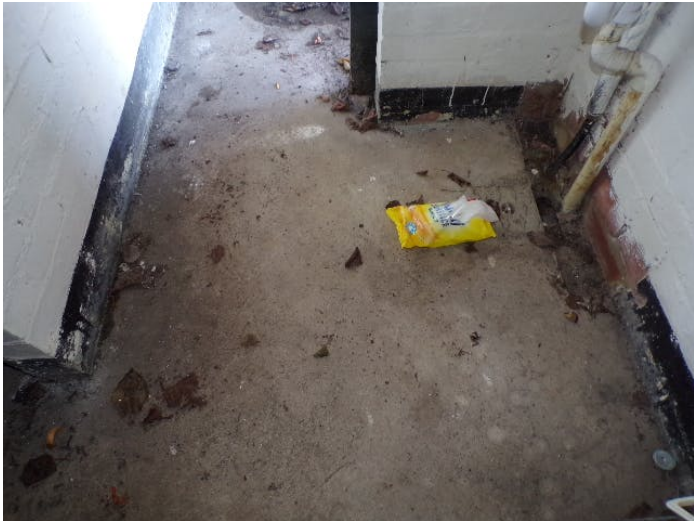
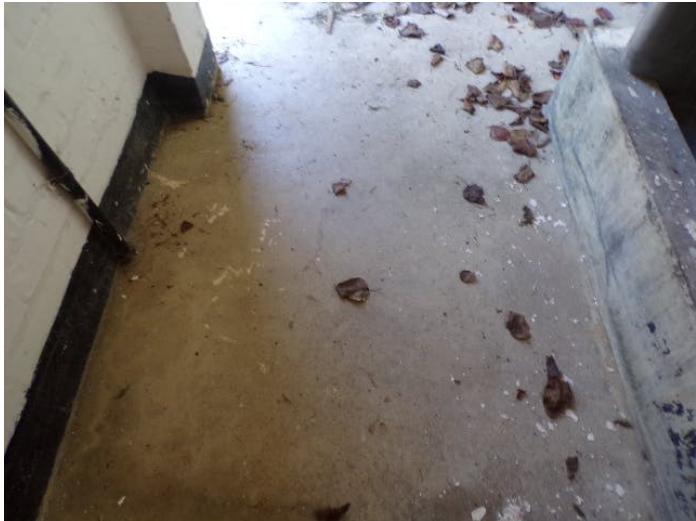
Toilet Block > ground floor > throughout all rooms >

| Access / Notes | No Access / Not accessed within or below concrete roof and floor slabs | | |
