## A Demolition Survey Report for Asbestos-Containing Materials at:

**SITE LOCATION:** Changing Rooms and Toilet Block in Church Road, Wootton, Bedfordshire, MK43 9EU

**PREPARED FOR:** Wootton Parish Council

**SURVEY REF:** AGG 611

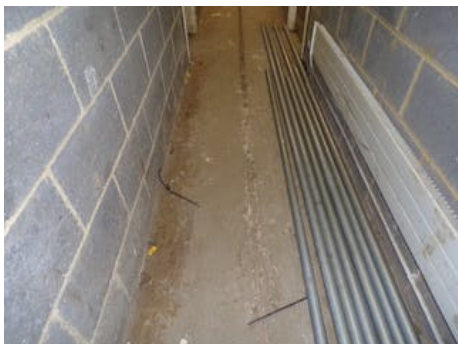
| Building / Level / Location | Inspect | Access / Notes | Photo | Page |
|---|---|---|---|---|
| Changing Rooms / ground floor / throughout all rooms | -- | No Access / Not accessed within or below concrete floor slab | | 36 |

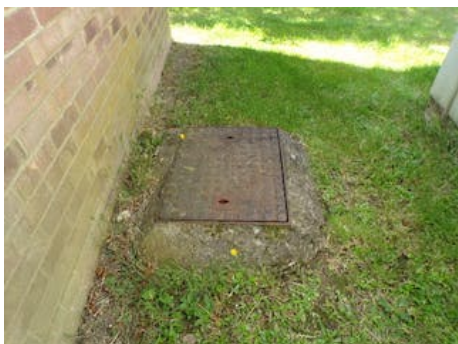
| Building / Level / Location | Inspect | Access / Notes | Photo | Page |
|---|---|---|---|---|
| Changing Rooms / ground floor, external / between changing rooms and toilet block | below drain cover | No Access / outside the scope of this survey | | 41 |

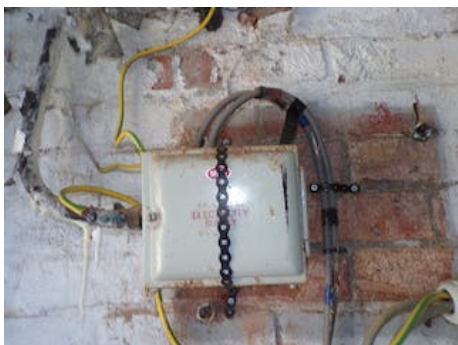
| Building / Level / Location | Inspect | Access / Notes | Photo | Page |
|---|---|---|---|---|
| Toilet Block / ground floor / 003 - Gents toilet | within main electric switch box | No Access / Live at the time of this survey | | 45 |

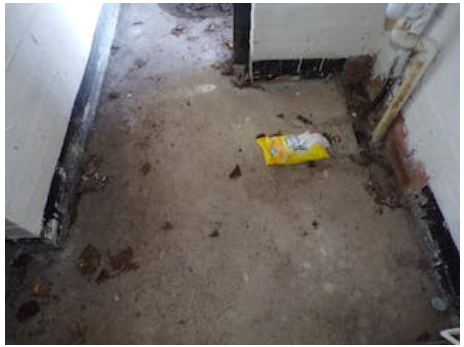
| Building / Level / Location | Inspect | Access / Notes | Photo | Page |
|---|---|---|---|---|
| Toilet Block / ground floor / throughout all rooms | -- | No Access / Not accessed within or below concrete roof and floor slabs | | 46 |

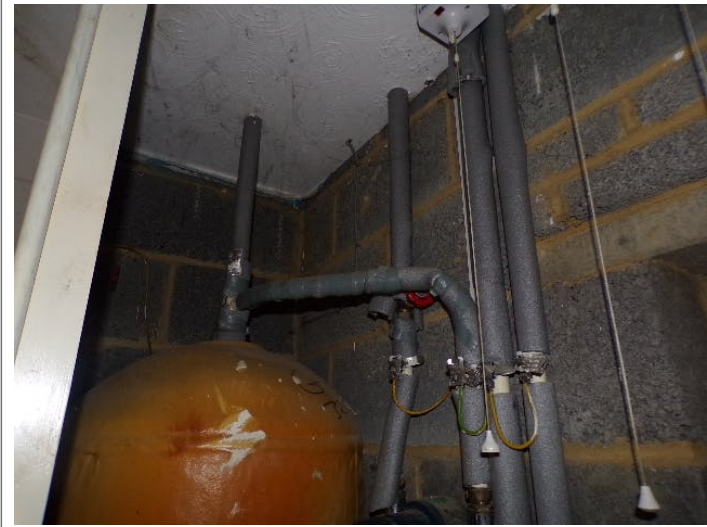
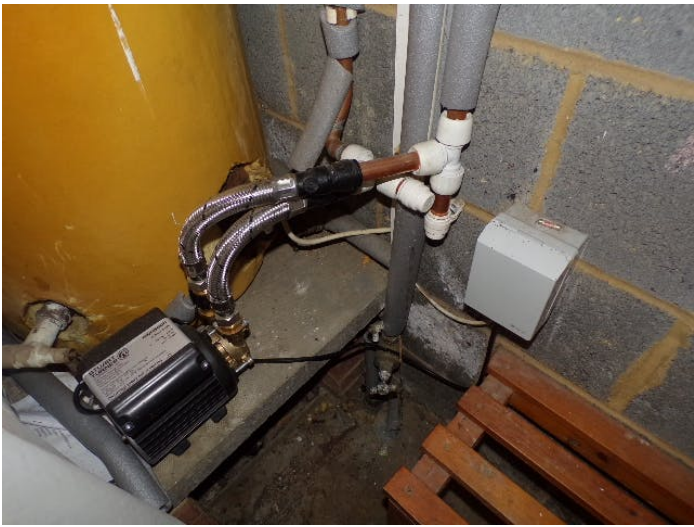
| Location | 005 - single shower room | Item | door frame (timber), walls ceramic tiles and (block), floor (quarry tiles and screed), hot water cylinder and pipe lagging (foam) |
| Material | no asbestos-containing materials were evident | Extent | |

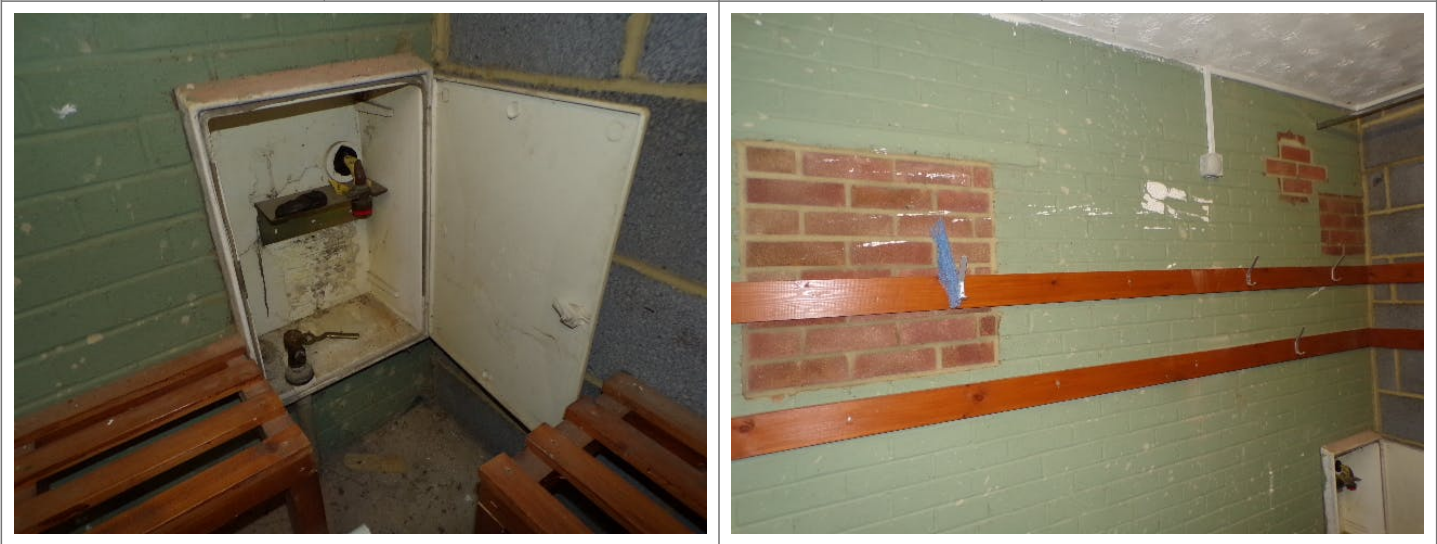
| Location | 006 - changing room | Item | door (timber), door frame (timber), walls (block and brick), floor (screed) and within redundant gas meter cabinet (fibreglass) |
| Material | no asbestos-containing materials were evident | Extent | |

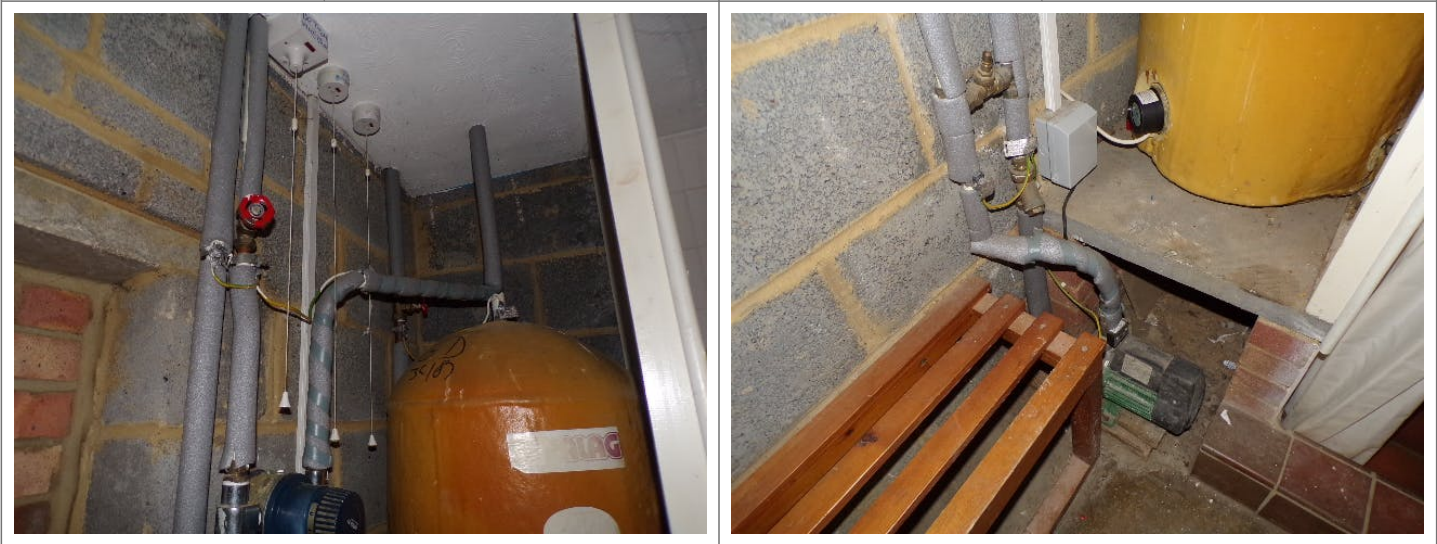
| Location | 008 - single shower room | Item | door frame (timber), walls ceramic tiles and (block), floor (quarry tiles and screed), hot water cylinder and pipe lagging (foam) |
| Material | no asbestos-containing materials were evident | Extent | |

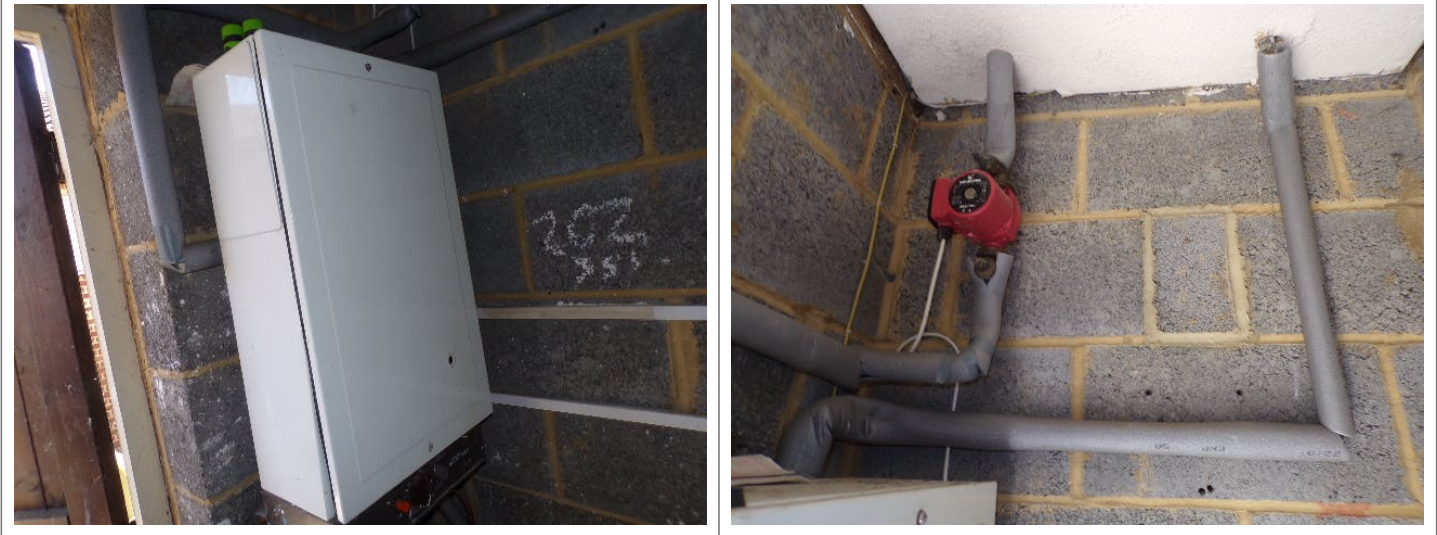
| Location | 014- boiler room | Item | door (timber), door frame (timber), walls (block), floor (screed), boiler (Potterton Flamingo 11) and pipe lagging (foam) |
| Material | no asbestos-containing materials were evident | Extent | |

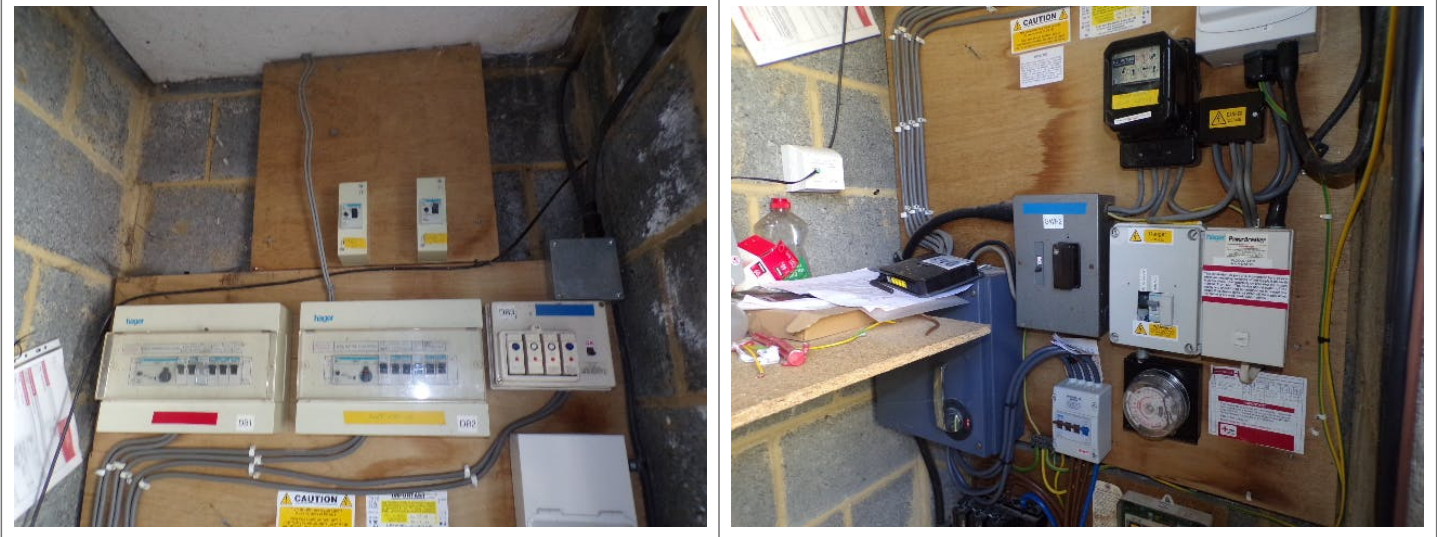
| Location | 015 - cctv room | Item | door (timber), door frame (timber), walls (block), floor (screed), electrics backing board (timber) and consumer units (modern) |
| Material | no asbestos-containing materials were evident | Extent | |

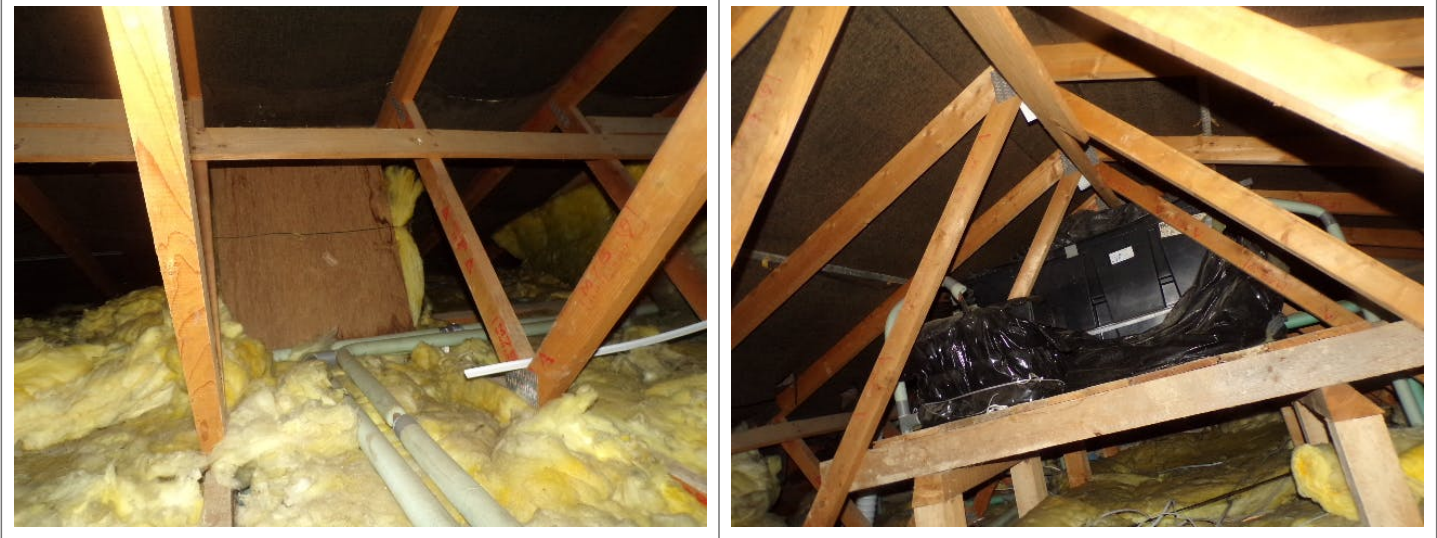
| Location | 013 - loft space | Item | access hatch (timber), underside of felt roof covering, walls (block), skylight surrounds (timber), floor (mmmf loft insulation roll), 2 X water tanks (plastic) and pipe lagging (foam) |
| Material | no asbestos-containing materials were evident | Extent | |
